Experimental and Computational Investigation of Particle Filtration Mechanisms in Partially Damaged DPFs

Onoufrios Haralampous, Marios Mastrokalos, Fotini Tzorbatzoglou, and Chris Dritselis

University of Thessaly

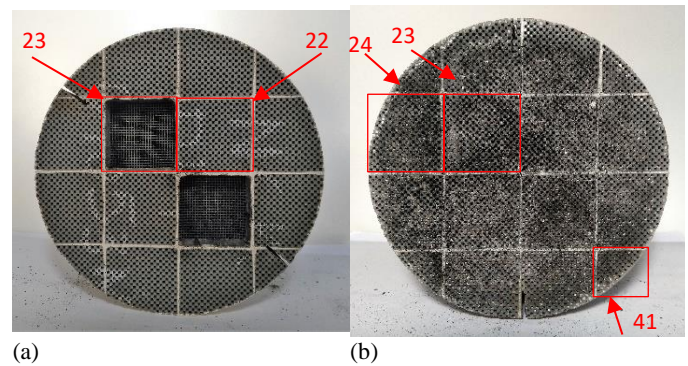
Figure 4a shows the rear face of the unplugged DPF after disassembly. The missing plugs can be identified in segments 23 and 32, as numbered from the frontal face. A representative intact segment (22) and a segment without plugs (23) were selected for further examination. Particulate matter is evident in the segments without plugs, but the rest of the segments are quite clean. Figure 4b presents the rear face of the cracked DPF. Black deposits can be observed in several outlet channels and a significant number of them are almost or completely blocked. Three representative segments at different locations, 23, 24 and 41 were selected to study the failure effects in the cracked DPF.

Figure 4. Rear faces of the two damaged DPFs and selected segments for further study: (a) unplugged DPF (b) cracked DPF.

The rear plugs were removed in two of the central segments of the unplugged DPF, as shown in Figure 4a. This corresponds to 14% of the total frontal area. Another 8% of the frontal area corresponds to the cement at the segment interfaces and the periphery. The experimental

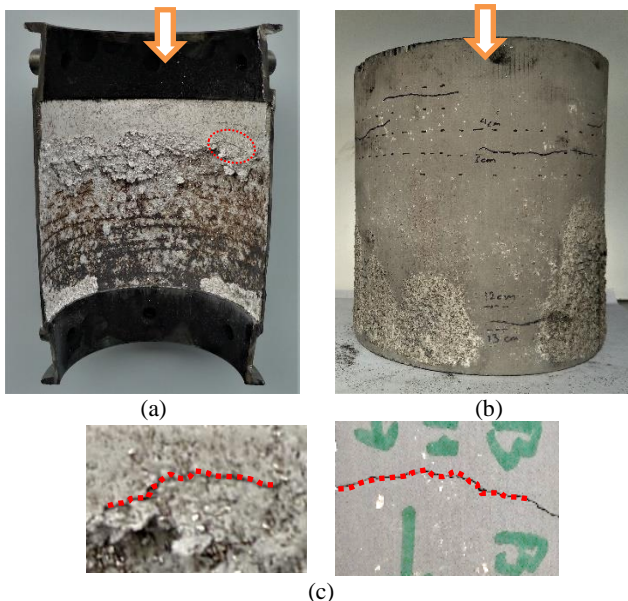
Figure 11a and b respectively show the canning and DPF after disassembly. The insulating mat was partly destroyed and some of it had hardened and attached to the monolith periphery especially at the rear half of the filter periphery. Higher temperatures were attained in this location during the regeneration. Several ring-off cracks were evident on the monolith, mostly in the region of 2-5 cm from the entrance and secondly at 12-13 cm. Figure 11c shows the detail of a crack and the corresponding black mark on the mat from PM leakage. The width of the PM line on the mat hints to a rather small amount of exhaust gas leakage. A possible explanation is that leaked particles accumulate on the crack and block it shortly after the crack development.

Figure 11. Images of the cracked DPF after disassembly showing (a) insulating mat failure, (b) cracks on the monolith periphery and (c) the detail of PM leak from the periphery to the insulating mat marked with a red line in both surfaces.

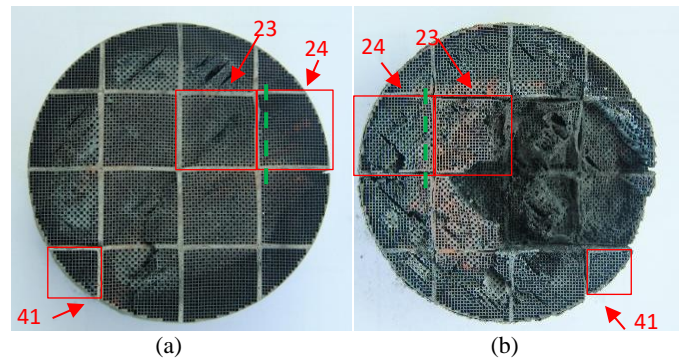
Internal faults were revealed after the slicing of the cracked DPF. Figure 12a shows the inlet face of slice C, about 50 mm from entrance. Diagonal cracks are evident in most of the segments and about 50% of the central area has a lighter color than the periphery. A closer examination in this area shows a white material in the inlet channels, with some of them being completely blocked. Figure 12b shows the outlet face of section D, about 130 mm from entrance. This slice broke up during cutting and revealed extended substrate melting in the central and quadrilateral peripheral segments. This was combined with large diagonal cracks in many locations. Three segments from different locations were selected for further examination, as marked on the images. In addition, a plane in segment 24 was selected to inspect the interior of the channels.

Figure 12. Images of the cracked DPF after slicing showing (a) diagonal cracks at the inlet face of slice C and (b) diagonal cracks and substrate melting on the outlet face of slice D. The segments marked with red squares were selected for further examination. The green line shows a plane discussed below.

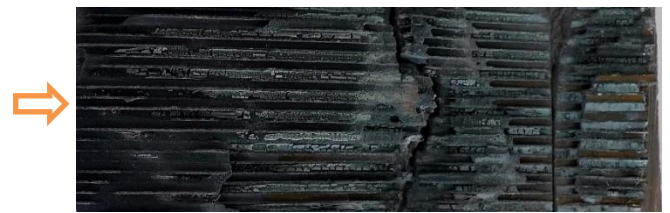
Figure 13 shows the state of inlet and outlet channels in this section. A light colored material is obvious inside the inlet channels, mostly in the form of a fractured layer. It should be noted that this DPF had not been used before this study and no ash accumulation was expected. The white material form and color is more or less similar upstream and downstream of the substrate melting. There is no evidence of the same material in the outlet channels, some of which have a distinct brownish color. This suggests that the unknown material accumulated in the inlet channels before the substrate melting. Moreover, the accumulation of this material was verified with the DPF weight, which was about 46g more than that expected after the uncontrolled regeneration. At the peak of the regeneration, exhaust gas temperatures reached as high as 750°C at the DOC outlet and 1400°C at the DPF. The origin of the material is still under investigation.

Figure 13. Side of segment 24, slice C to E, showing the substrate melting and the internal of the channels after furnace regeneration.

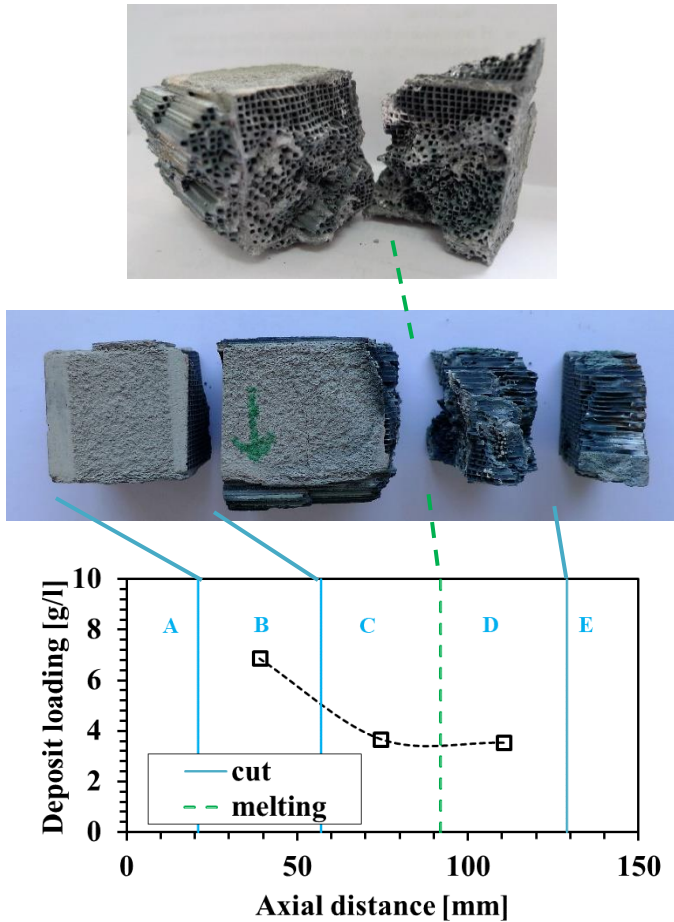
Detailed results for the central segment are shown in Figure 14. Substrate melting is evident at the interface between blocks C and D. As a result, exhaust gas could flow freely from the inlet to the outlet channels, although in some cases the melted material blocked completely the channels. A maximum value of the deposit loading of 7 g/l was obtained near the entrance, while lower values appeared around the melting location. Similar results are shown in Figure 15 for segment 24. Block B was separated in two parts after the furnace regeneration, revealing an additional crack. It seems that this crack did not affect the local deposit concentration, which remained high. The minimum value is encountered in block D, where melting took place. The same trend was verified in the triangular segment (41). Substrate melting was observed in the marked area of segment D. In all cases, a minimum loading value is encountered at the melting location, while cracks do not seem to affect the profile.

Figure 14 Axial deposit distribution in central segment (23) of cracked DPF and images of the respective blocks.

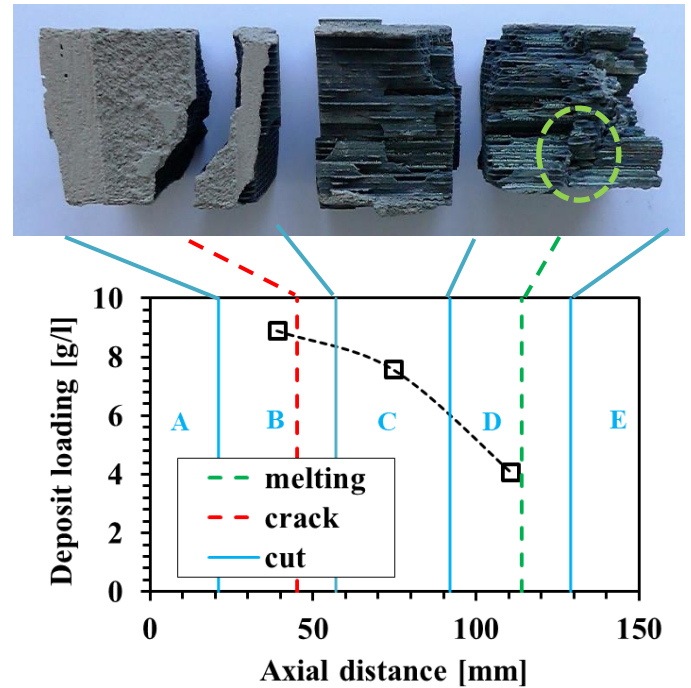
Figure 15. Axial deposit distribution in quadrilateral peripheral segment (24) of cracked DPF and images of the respective blocks.

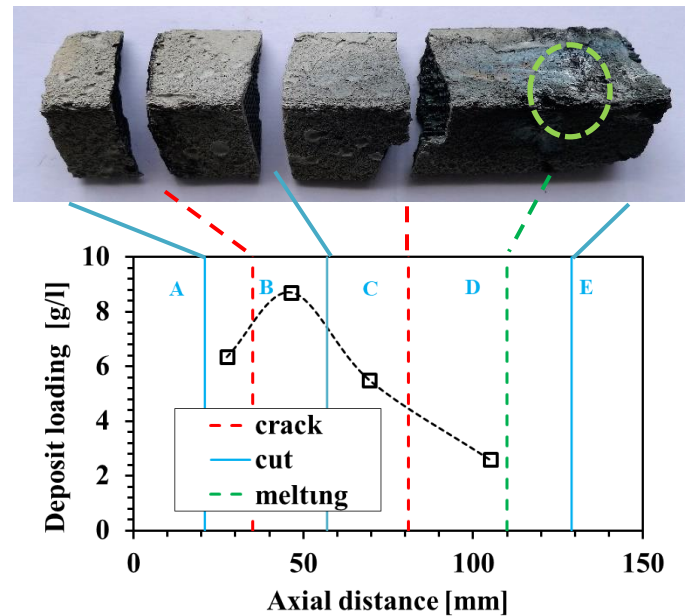
Figure 16. Axial deposit distribution in triangular peripheral segment (41) of cracked DPF and images of the respective blocks.
