*National Technical University of Athens
School of Applied Mathematical & Physical Sciences
Department of Mechanics
Laboratory for Testing and Materials*

**Enlightening critical details of a standardized procedure
used to determine the fracture toughness
of brittle structural materials**

Ermioni D. Pasiou, Andronikos Loukidis,
Dimos Triantis and Stavros K. Kourkoulis

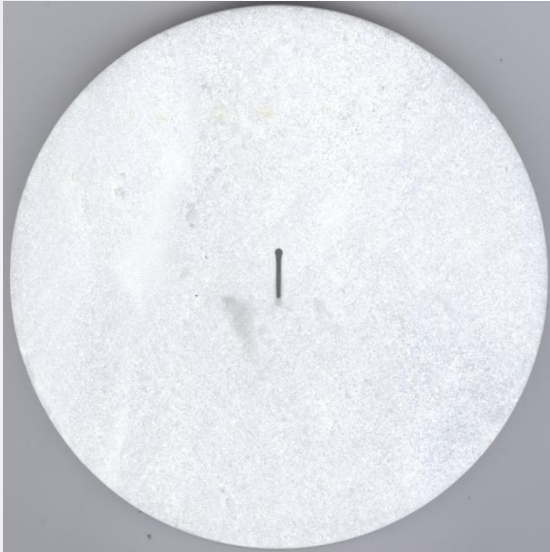
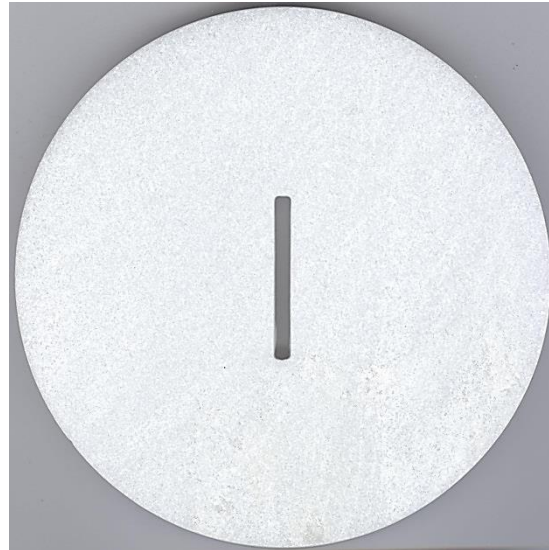
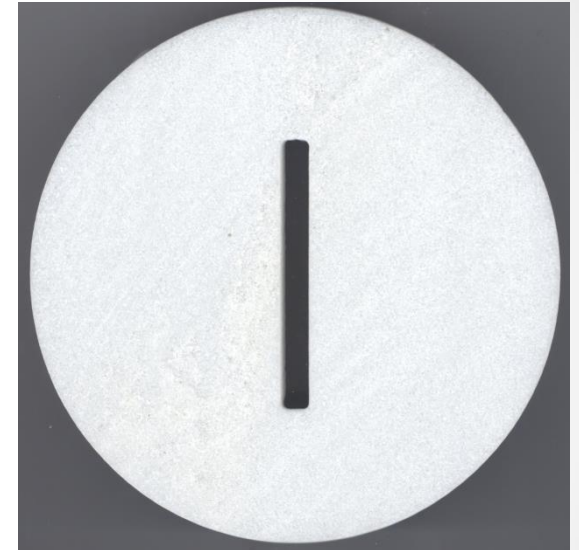
The specimens

Waterjet cutting technology was used to machine the notches.

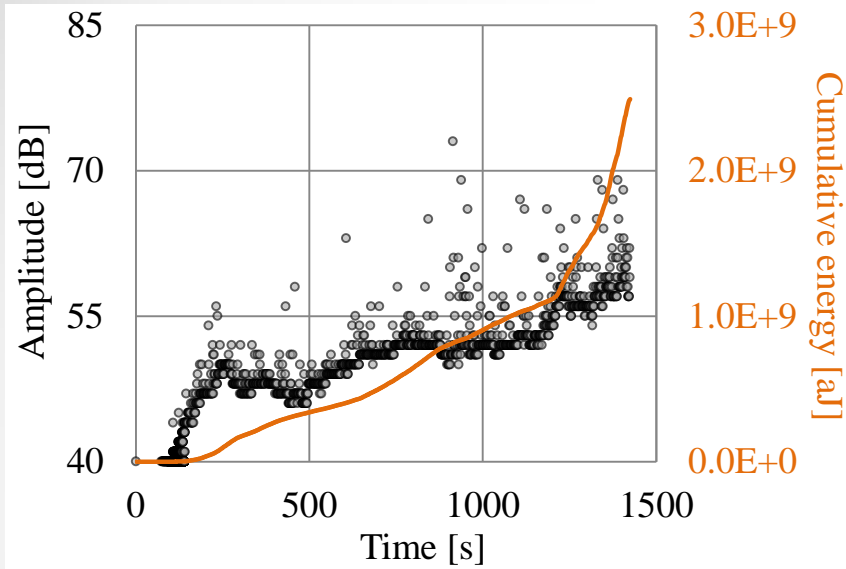
Sensor 4
(upper part of the disc)

Sensor 2
(lower part of the disc)
