Experimental and Computational Investigation of Particle Filtration Mechanisms in Partially Damaged DPFs

Onoufrios Haralampous, Marios Mastrokalos, Fotini Tzorbatzoglou, and Chris Dritselis

University of Thessaly

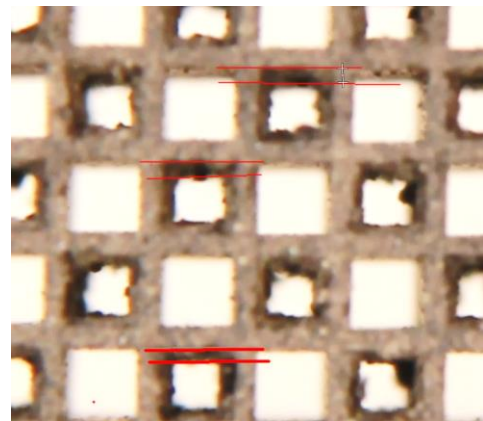
A high resolution camera (18 MP) was used to study the inlet and outlet face of the DPF blocks in these segments. Special care was given to align the camera to the channel axis. Figure 5 shows an image from the second block in the unplugged segment (B22). The deposit layer can be discerned as the dark material on the wall surface of the inlet channels. Additionally, some protrusions extend beyond the layer surface. Channels with rather uniform deposit layer and less protrusions were selected to measure the deposit layer thickness. At

Figure 5. Frontal face of an intact segment (block B22) from the unplugged DPF. Marked distances were used to estimate deposit layer thickness.

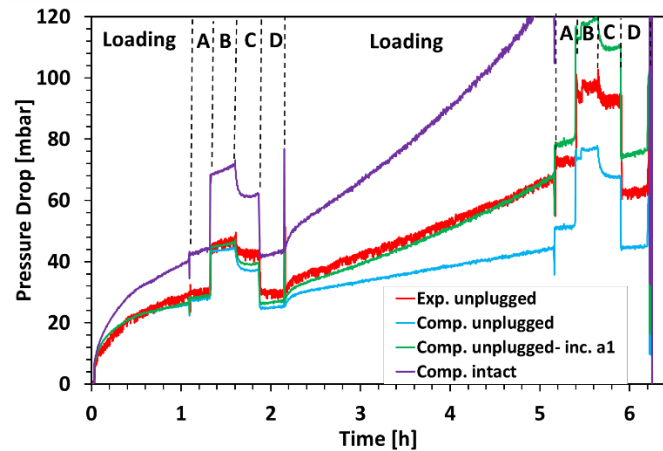
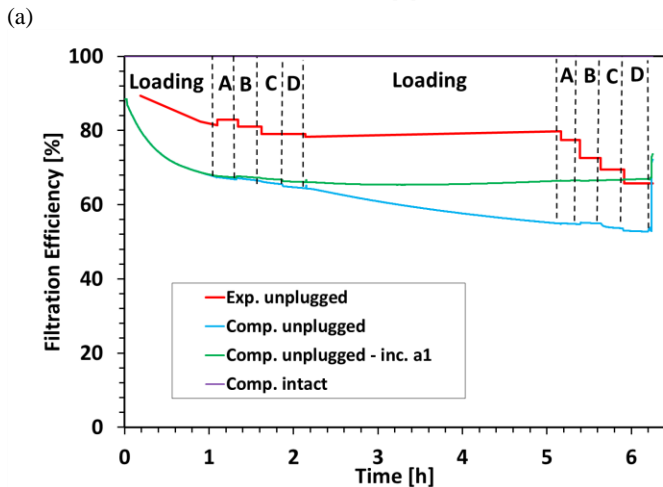
Figure 7. Pressure drop and mass-based filtration efficiency of unpluged DPF. Red line: experimental measurements, magenta line: computational results corresponding to intact filter, blue line: computational results without hydrodynamic factor, green line: computational results including hydrodynamic factor

Figure 7a depicts the evolution of pressure drop for the unpluged DPF. It is clearly lower than the pressure drop of the intact DPF, which is included in the same graph for reference. The initial prediction is very good regardless of the model calibration. The prediction of the pressure drop remains good for the initial loading phase and the first scanning, but deviates in the main loading phase. The backpressure gradient in the main loading phase seems to be rather high when compared to the measurements of Dabhoiwala et al. [19]. A preliminary sensitivity analysis, showed that the permeability of the deposit layer and substrate has small effect on the calculated pressure drop gradient. The governing phenomena for pressure drop take place in the open channels. In order to achieve good pressure drop prediction after the first 2h, an increased channel pressure coefficient α_1 was used. A possible explanation is that the layer roughness is not negligible and should be taken into account as explained by Kandlikar et al. [20]. In this case, transition to turbulent flow might take place at Reynolds numbers lower than the standard value. Moreover, porous walls can also lead to lower the critical Re number values [21]. In our case, the channel Re number reaches values of 1800 during the scanning phase in the vicinity of the unpluged channel entrance.

The respective experimental and computational filtration efficiency calculated from the MSS signal is shown in Figure 7b. The experimental value is very close to 80% throughout the loading, with the exception of the first and the second scanning phase. A gradual decrease is noticeable from point A to D. Similar trends are qualitatively predicted by the model, albeit at a lower level. Particle collection according to the model assumptions takes place both in the intact and damaged segments, as a fraction of the flow is forced through the wall. The rest of the flow leaks directly through the open channels, which essentially controls filtration efficiency. According to the model, the flow redistributes as the deposit accumulates, resulting in even lower efficiency. The sudden drop during the first 1h is related to the accumulation of deposit inside the wall pores. During the main loading phase, the experimental filtration efficiency remains almost constant, the original model shows a considerable drop, while the model with increased α_1 exhibits a similar behavior to the experimental one. In the latter case, the flow resistance increases at the same rate in the intact and unpluged segment, leading to a minimal redistribution. The discrepancy of the predicted filtration efficiency points out an additional collection mechanism that takes place in the open channels. Possible explanations could be the interception of particles at protrusions extending beyond the deposit layer and/or the turbulent flow in the channels.

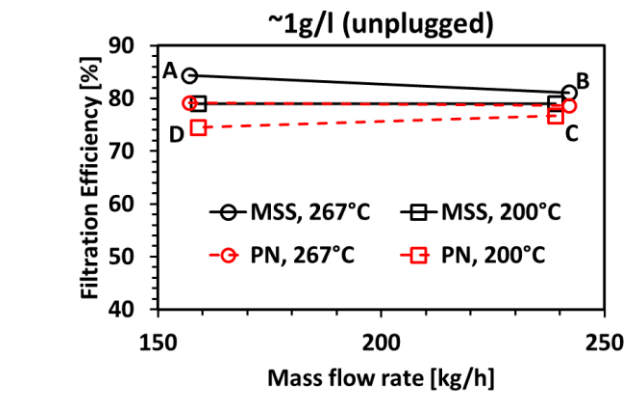
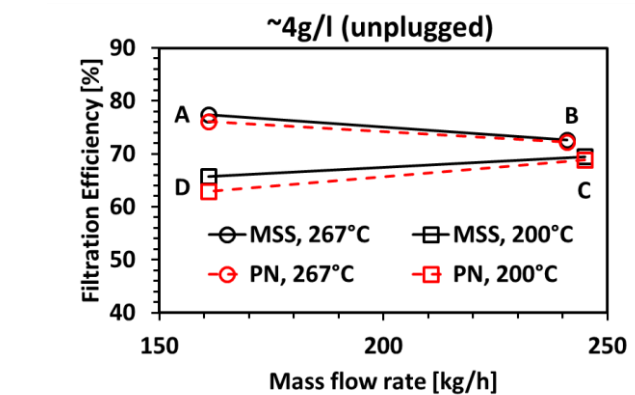
Figure 8. MSS derived filtration efficiency of the unpluged DPF as a function of mass flow rate and temperature for (a) low and (b) moderate deposit loading.

In order to investigate the effect of flow rate, temperature and deposit loading on the mass- and number-based filtration efficiencies, the processed values for the four scanning points are shown in Figure 8. Mass flow rate seems to have minimal effect on the efficiency, as indicated in both graphs. Efficiency increases weakly with

temperature, as shown by the comparison of results obtained at the two temperatures. It should be noted, that the increase of flow rate from point A to B is expected to cause some migration or restructuring of the loosely deposited particulate matter. This is consistent with the deviation between the experimental and calculated pressure drop at points B, C and D. Thus, the comparison focuses mostly on points B to D in order to avoid this effect. Similar trends are predicted by the model although to a lesser extent. The comparison of the two graphs suggests that the deposit loading accumulation from 1 to 4g/l results in a reduced efficiency of about 10%. Interestingly, the FE values based on the particle number are consistently lower than those based on particle mass. This indicates that larger size particles are collected more efficiently than smaller. Again, this could be related to an additional filtration mechanism, besides surface filtration.

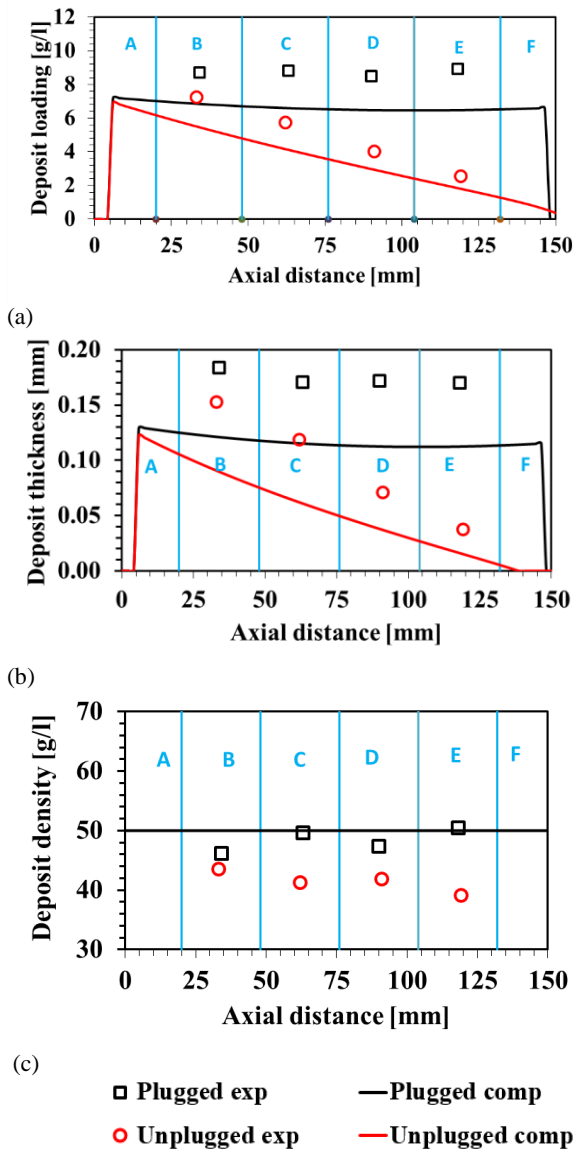
Figure 9. Intact and unplugged DPF segments: Profiles of (a) Soot loading, (b) soot thickness and (c) soot density.

Figure 9 shows the deposit properties profiles obtained from the experimental examination and the simulation. Only the results with the modified a_1 are presented, as all the simulations produced almost identical results. The first graph shows the deposit loading distribution

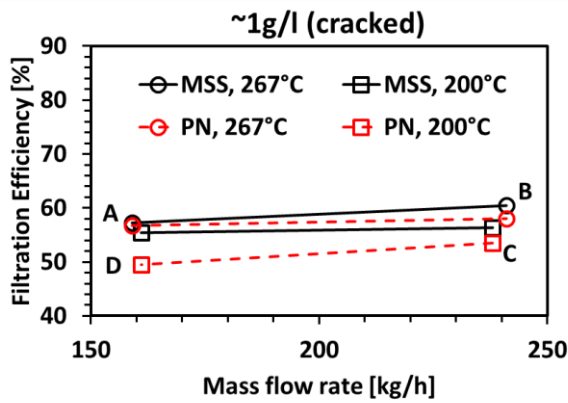
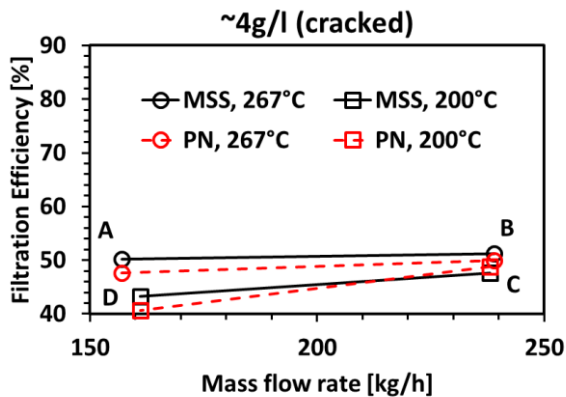
As shown in Table 2, the cracked DPF approached values of the cumulative efficiency close to 50%, revealing a more severe failure than the unplugged DPF. The cumulative efficiency is in agreement with the instantaneous efficiencies obtained from the MSS signal during the scanning phase. Furthermore, the dependence on the mass flow rate and temperature is rather small, as depicted in Figure 10. The number-based efficiency is again consistently lower than the mass-based. Interestingly, the small drop of efficiency from point A to B is not observed in this case.

Figure 10. MSS derived filtration efficiency of the cracked DPF as a function of mass flow rate and temperature for (a) low and (b) moderate deposit loading.

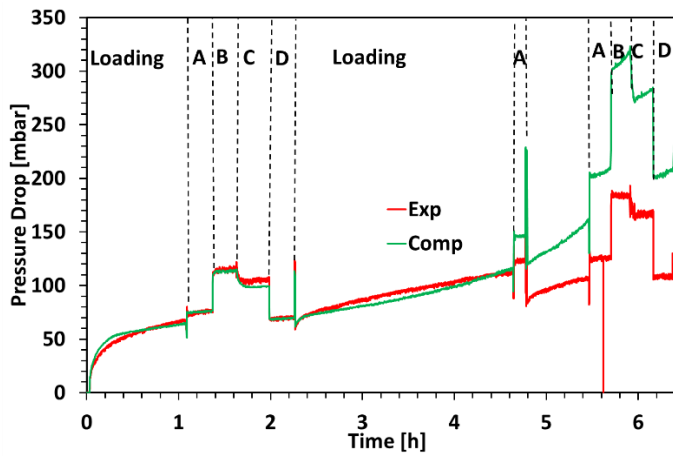
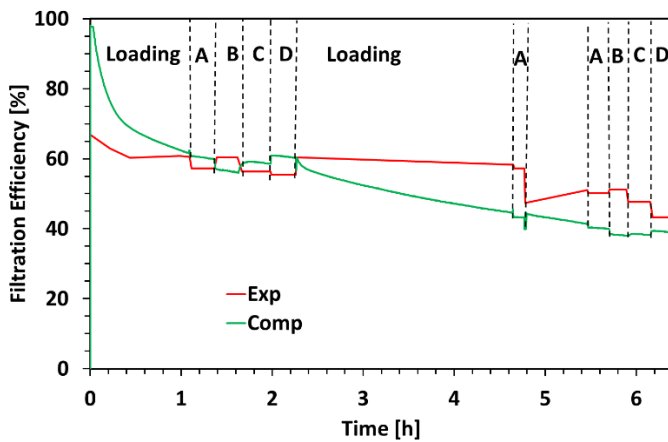
Figure 17. Pressure drop and mass-based filtration efficiency of cracked DPF. Red line: experimental measurements, green line: computational results.

Figure 17 shows the pressure drop and mass-based filtration efficiency obtained experimentally and computationally. A good agreement is evident for both magnitudes during the initial loading and the first scanning phase. Although not shown in the graph, the experimental pressure drop is actually higher than that of a hypothetical intact filter. The main loading starts at 2.2h and ends at 5.4h with an interruption at 4.6h. During the interruption, the engine operates at point A and for a few seconds it is further accelerated resulting in high flow rate. After this point, the experimental backpressure drops noticeably, while the computational is not affected. Deposit migration or restructuring inside the channel or at the melting location is again a possible explanation. It is worth mentioning, that the intact filter located downstream did not demonstrate this pressure drop discontinuity. In other words, if any deposit migration took place in the failed DPF, it didn't reach the intact filter. It is also interesting to note that the instantaneous efficiency dropped significantly at the same time. This efficiency drop is a manifestation of the same phenomenon that appeared in the unplugged DPF at the transition from point A to B. Additionally a non-linear experimental backpressure buildup is evident during the loading from 2.2 to 4.6h, which could be related to deposit properties variation.

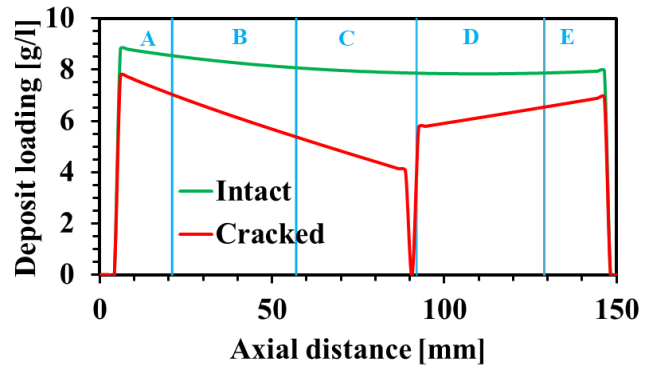
Finally the numerical deposit profile for the intact segment and the segment with internal failure denoted as cracked is shown in Figure 18. It presents the same trend of a maximum loading at the entrance, which decreases closer to the melting location. The experimental

profiles shown in previous figures could be viewed as a combination of the intact and cracked profiles.

Figure 18. Cracked DPF: Computational profile of deposit loading for intact segment (green line) and cracked segment (red line).
